# Framing Stage Inspection

Inspection Date: 1 Jan 2024

Property Address: 1 John St, Sydney 2000

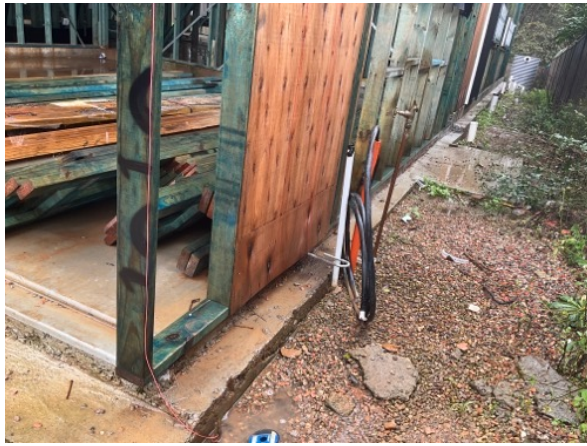
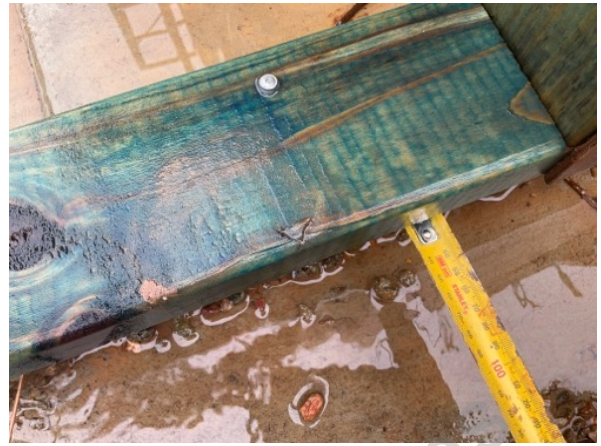
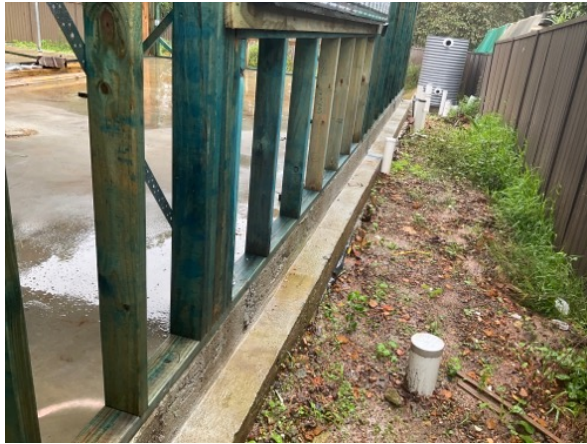
### Major Defect 2.01

Location: All External Areas

Finding: Bottom plate overhang

The floor slab in Garage area has been poured short across (front right hand side), which has left the bottom of the wall studs overhanging the edge of the slab by up to 28mm.  
New South Wales GUIDE TO STANDARDS AND TOLERANCES 2017 - 4.8 Bottom plates that overhang concrete slabs states:

Bottom plates that are less than 90 mm wide and overhang concrete slabs are defective.  
Bottom plates that are 90 mm wide or greater and overhang concrete slabs by more than 10 mm are defective.

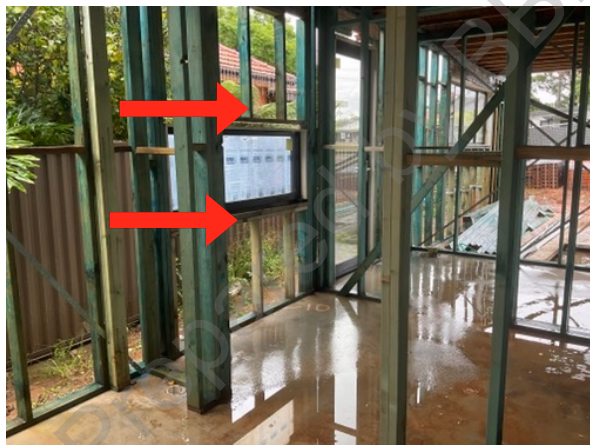
## Major Defect 2.02

Butlers

Missing windows sill, and headflashings

Sill and head flashings were missing at the time of inspection.

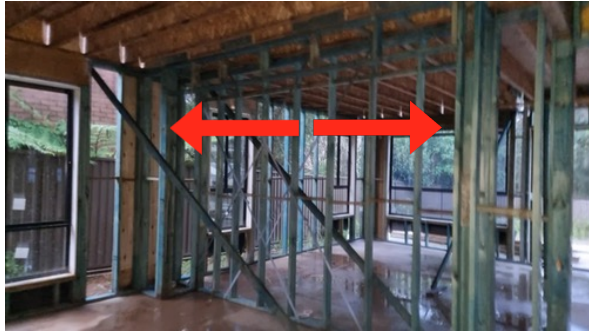
## Major Defect 2.03

Location: Home Cinema

Finding: Missing lintel

Non-Load-Bearing Wall the 2420mm wide opening in the Home Cinema room has not had a lintel installed across it to support the top plate that runs over it.

It is a requirement of Australian Standard, AS 1684 Residential Timber-Framed Construction, clause 6.3.6.5 Lintels in Non-Loadbearing Internal Walls that " For internal walls where ceiling loads are not supported and wall openings are wider than 1800 mm, the size of the lintel shall

be determined from Span Table 23 using a ceiling load width of 1800 mm.

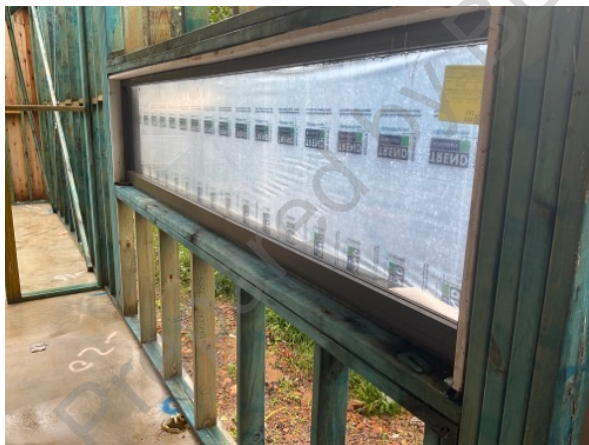
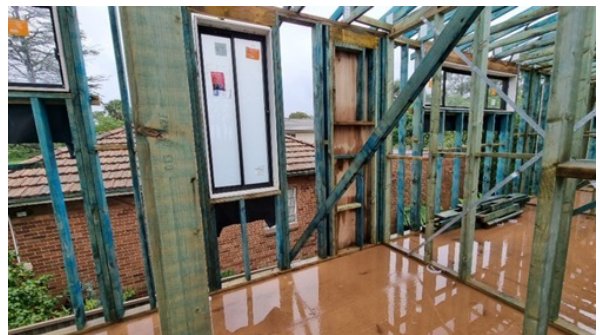
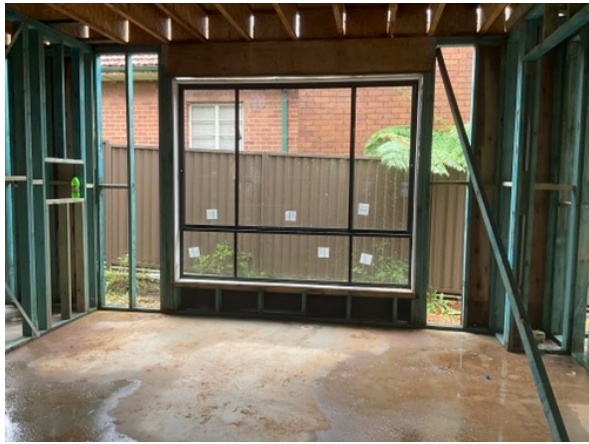
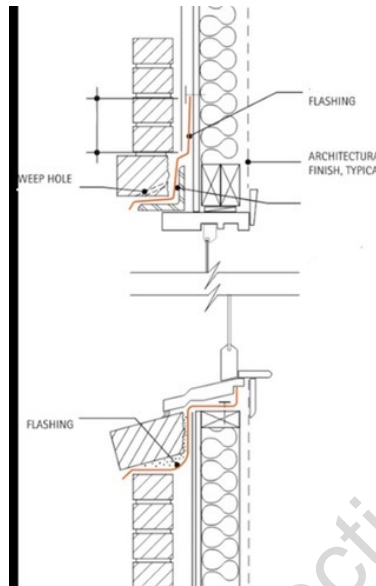
## Major Defect 2.04

Location: All External Areas

Finding: Sarking and windows head flashings not installed

Head flashings to all windows and sarking were not installed at the time of inspection.

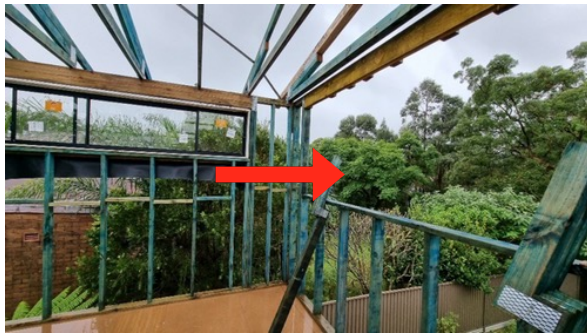
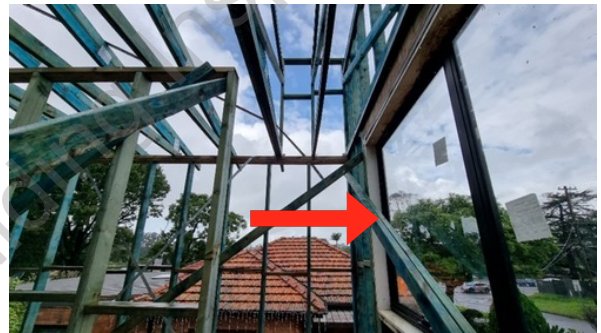
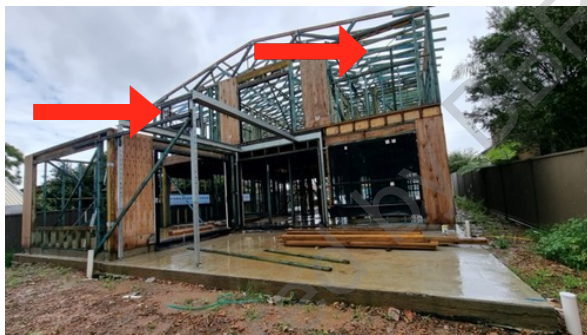
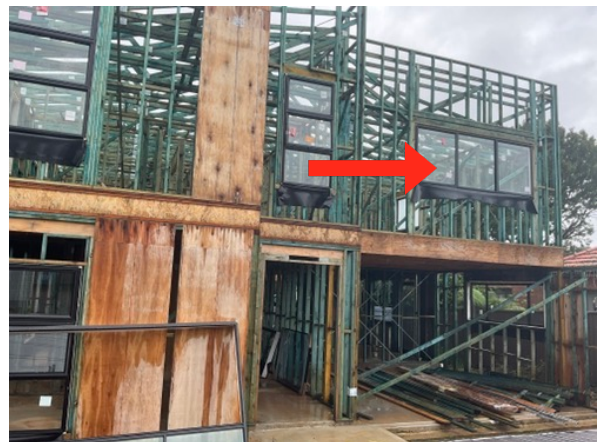
## Major Defect 2.05

Location: All External Areas

Finding: Missing windows sides and head flashings

Sides and head flashings were missing at the time of inspection however sill flashings were witnessed (except window in bedroom 3, not installed at the time of inspection). Please refer to architectural drawings for sectional claddings. Flashing required to sides of the windows where the external cladding is installed.

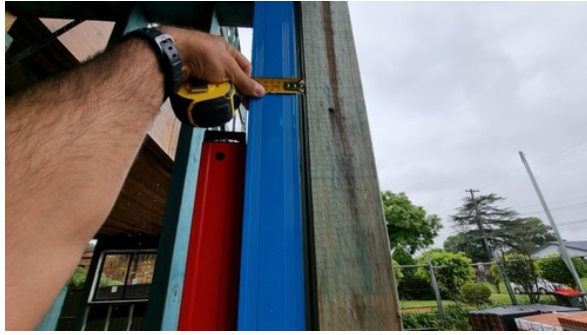
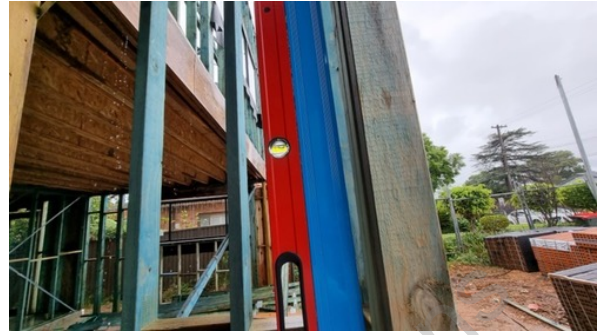
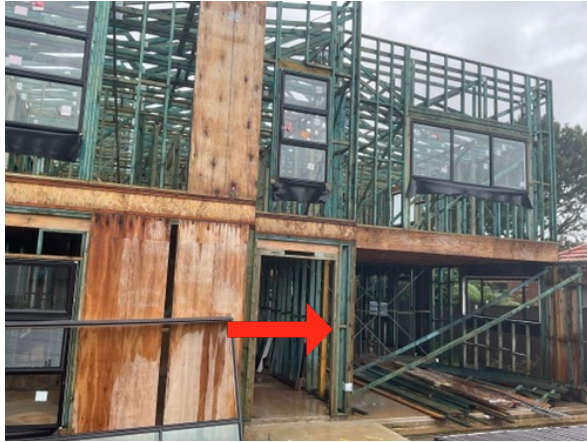
### Major Defect 2.06

Location: Hallway

Finding: Entry opening frame not plumb

Wall Not Installed Plumb The wall in the building entry has been installed up to 22mm out of plumb.

New South Wales GUIDE TO STANDARDS AND TOLERANCES 2017 4.2 Verticality or plumbness of steel and timber frames and exposed posts states that "Posts and wall frames are defective if they deviate from vertical by more than 5 mm over a 1.8 m height. Refer to Diagram E."

This wall, and the walls that run into it, will need to be re-plumbed into its correct position prior to the installation of the plaster.

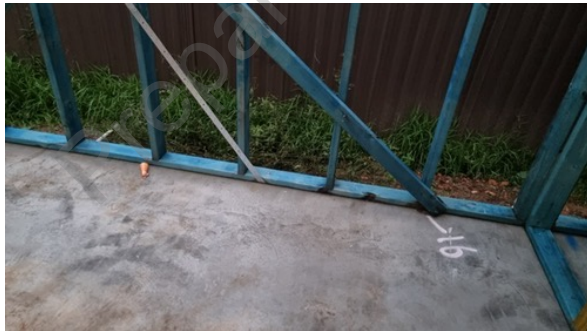
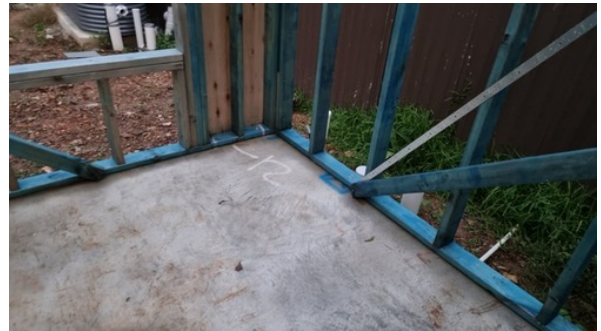
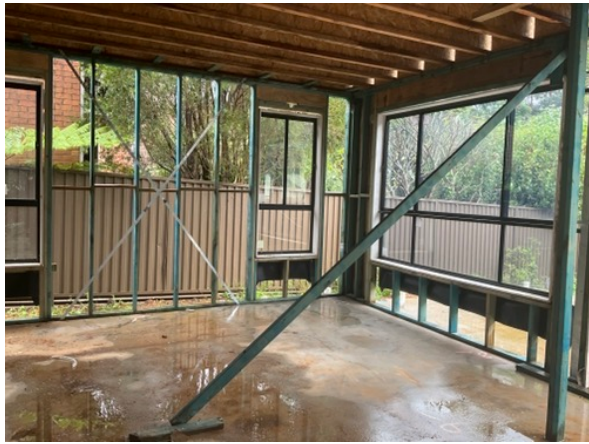
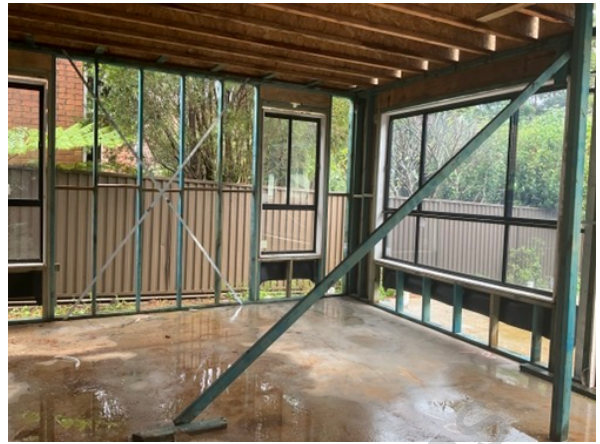
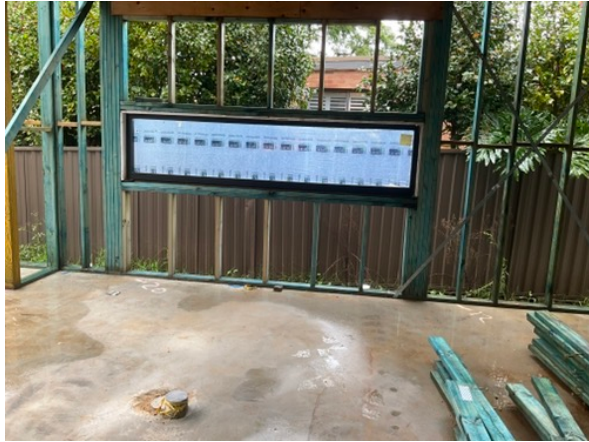
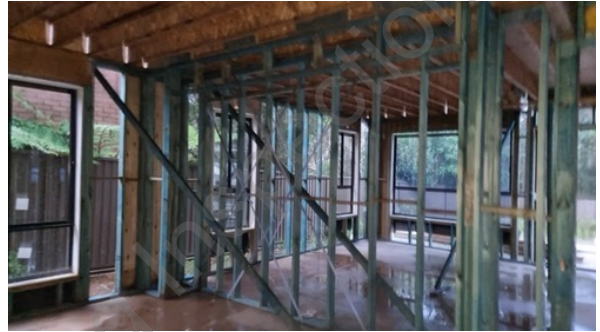
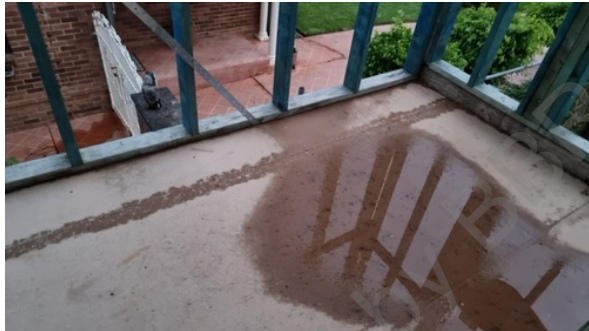
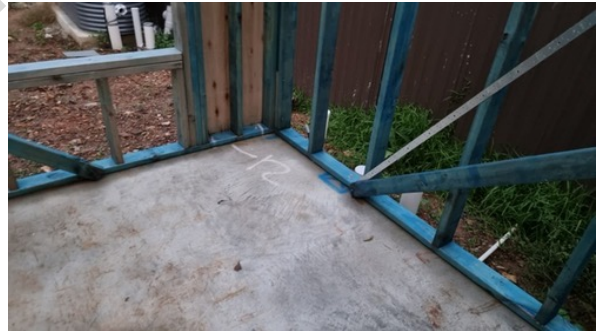
## Major Defect 2.07

Location: All Internal Areas

Finding: Missing metal straps to top and bottom plates

During my inspection I found no metal strap connections to the timber stud walls where the bracings installed.

It is a requirement of Australian Standard, AS 1684 Residential Timber-Framed Construction, clause 8.3.6.3 Structural wall bracing that

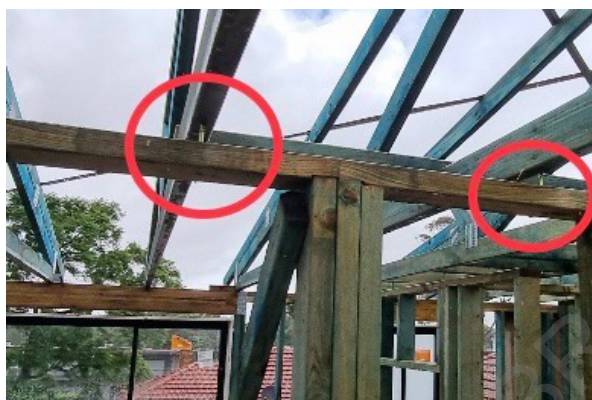
## Major Defect 2.08

Location: All Internal Areas

Finding: Fixing of top of bracing walls to trusses

No internal wall to truss brackets noted at the time of inspection, unless otherwise advised by the manufacturer. It is a requirement of Australian Standard, AS 1684 Residential Timber-Framed Construction, clause 6.2.5.2 Internal walls—Trussed roofs Non-loadbearing walls shall be kept a minimum of 10 mm below the underside of the bottom chord, or ceiling battens when used. Trusses shall be fixed to internal non-loadbearing walls as shown in Figure 6.11, or as required for bracing (see Clause 8.3.6.9).

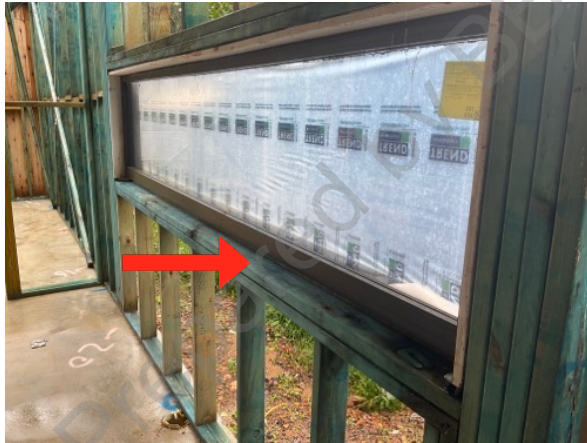
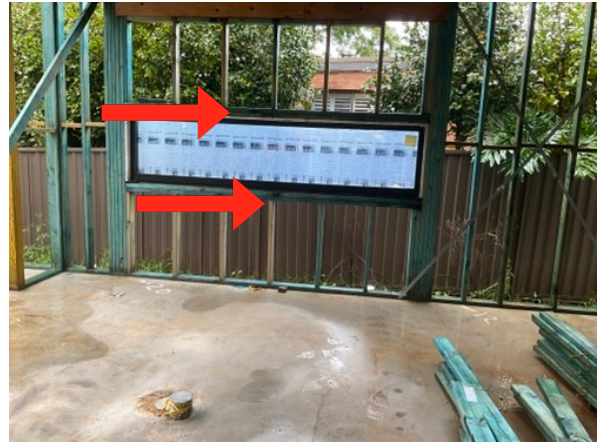
## Major Defect 2.09

Location: Kitchen

Finding: Missing windows sill and head flashings

Sill and head flashings were missing at the time of inspection.

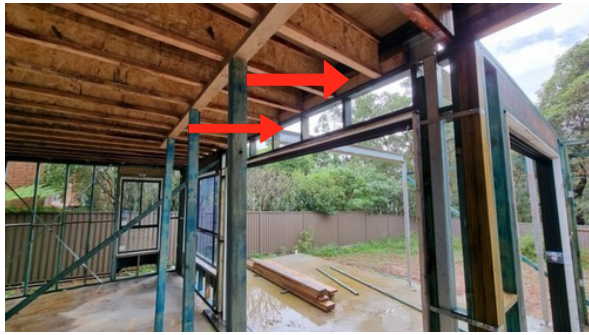
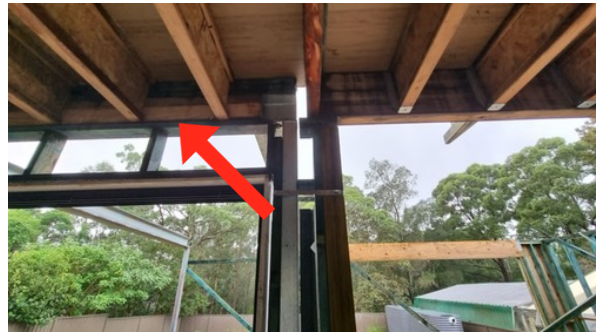
## Major Defect 2.10

Location: Dining room

Finding: Incomplete joists connections

The smart joists were not connected to the corresponding beam and were temporarily propped at the time of inspection. Joist hangers must be used to connect the smart beams to the structural beams, as instructed by the manufacturer. Please contact the manufacturer or structural engineer for further instructions.

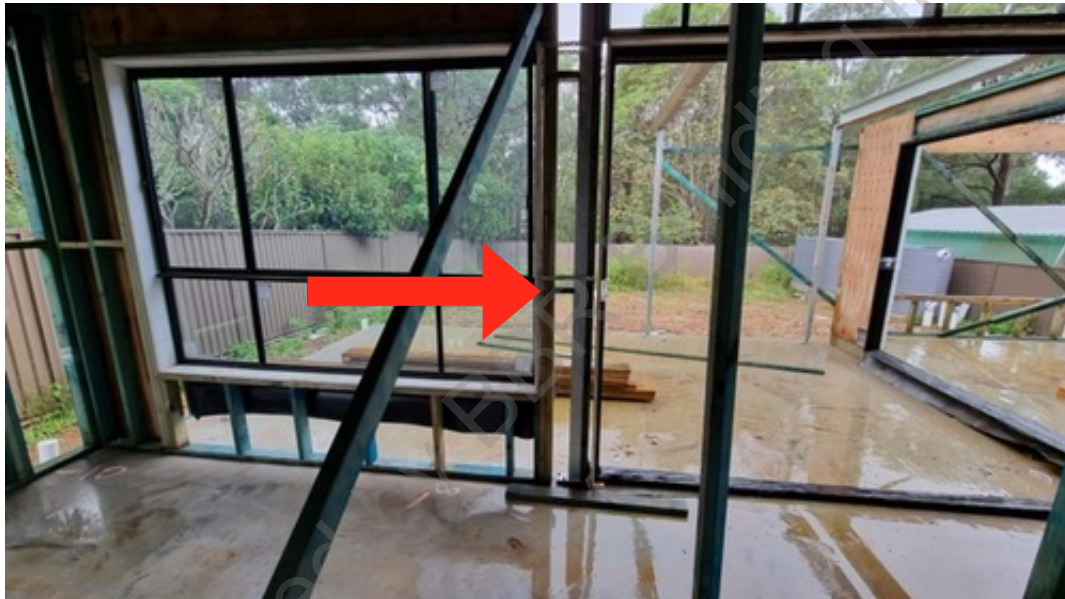
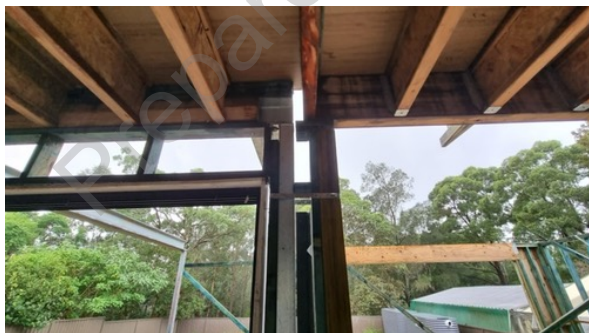
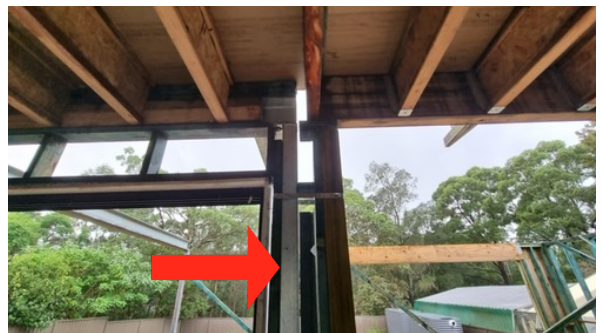
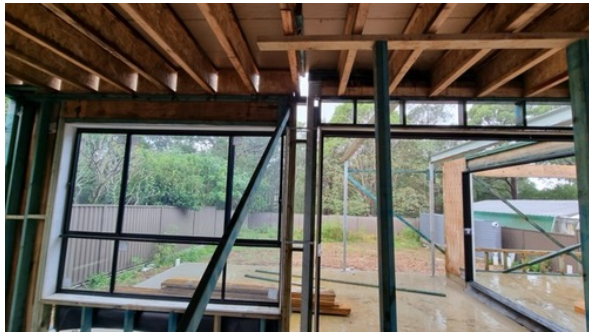
## Major Defect 2.11

Location: Dining room

Finding: Timber post connections to steel posts

Tensioned metal straps used to connect the metal structural posts to structural timber walls. Also gap noted between the structural elements and packers, no structural fasteners found between metal posts and timber stud walls at the time of inspection. Please contact your structural engineer or manufacturer to further advise.

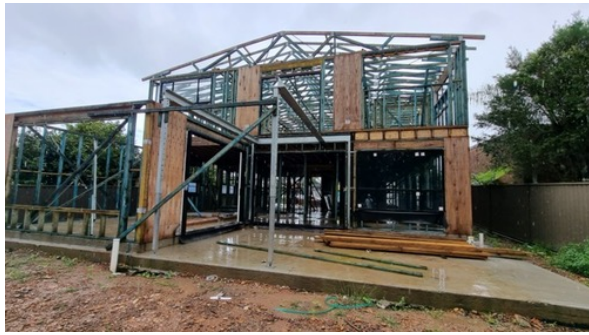
### For Your Information 5.01

Location:	Balcony
Finding:	Incomplete balcony
	Balcony was not completed at the time of inspection.

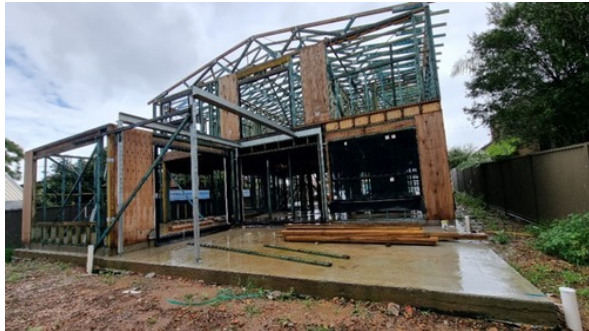
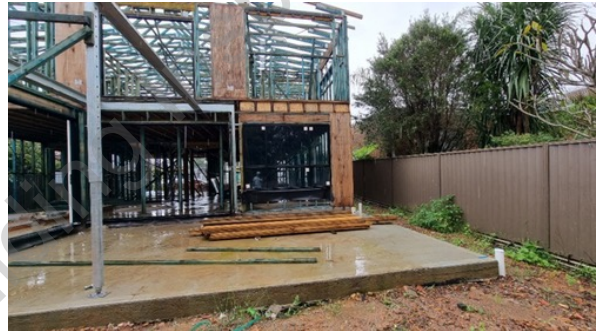
## For Your Information 5.02

Location: Roof exterior

Finding: Incomplete lower roof

Lower roofs to ground floor were not completed at the time of inspection.
