# Framing Stage Inspection

Inspection Date: 1 Jan 2024

Property Address: 1 John St, Sydney 2000

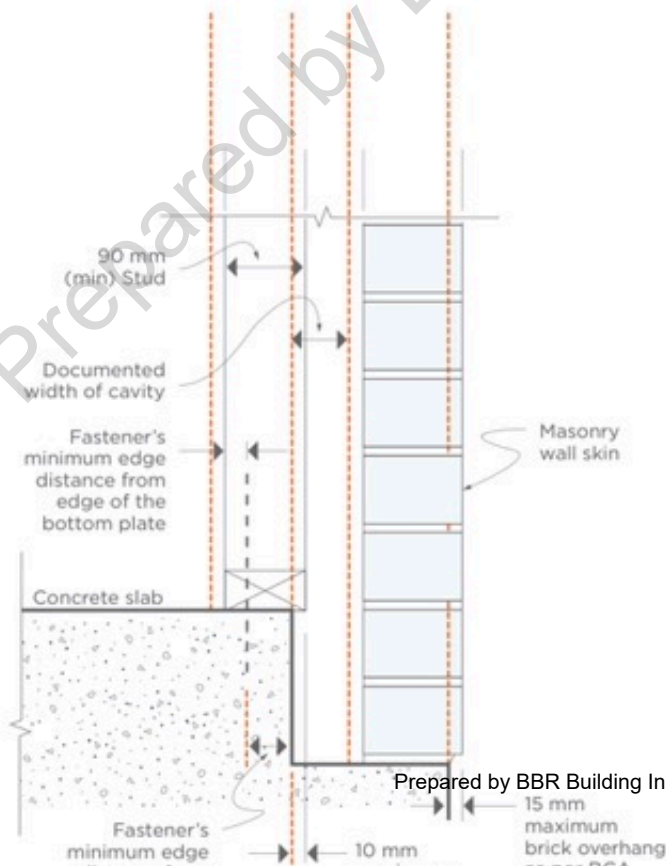
**DIAGRAM 4.08** BOTTOM PLATES THAT OVERHANG CONCRETE SLABS

Bottom plates that are less than 90 mm wide and overhang concrete slabs are defective.  
Bottom plates that are 90 mm wide or greater and overhang concrete slabs by more than 10 mm are defective.

Minimum cavity widths as required by the Building Code of Australia shall be maintained.

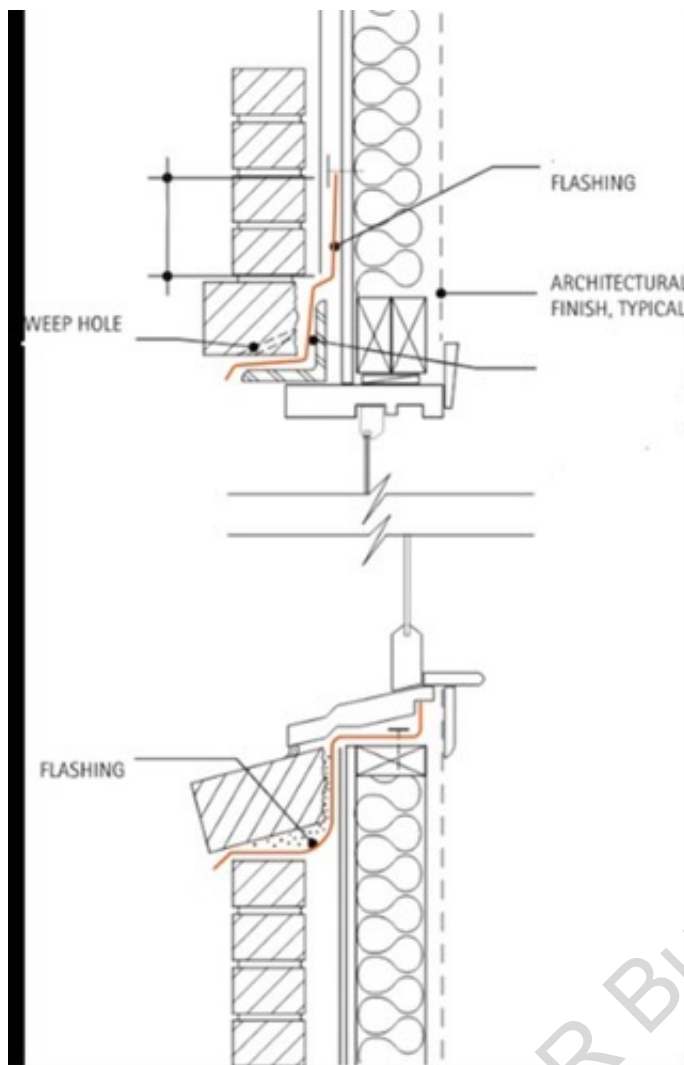
Missing windows sill, and headflashings

Sill and head flashings were missing at the time of inspection.

B) 300 mm above the opening; and

turned up in the cavity not less than 150 mm above the opening; and embedded not less than 30 mm into the masonry veneer; and attached to the window or wall framing.

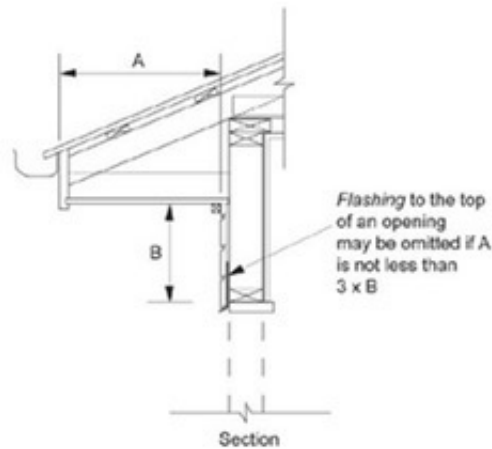
Figure 3.5.4.5 Weather protection of openings

Finding: Missing windows sides and head flashings

Sides and head flashings were missing at the time of inspection however sill flashings were witnessed (except window in bedroom 3, not installed at the time of inspection). Please refer to architectural drawings for sectional claddings. Flashing required to sides of the windows where the external cladding is installed.

(d) The top of an opening need not be flashed where it is adequately protected by an eave of a width more than 3 times the height of the cladding above the opening (See Figure 3.5.4.5).

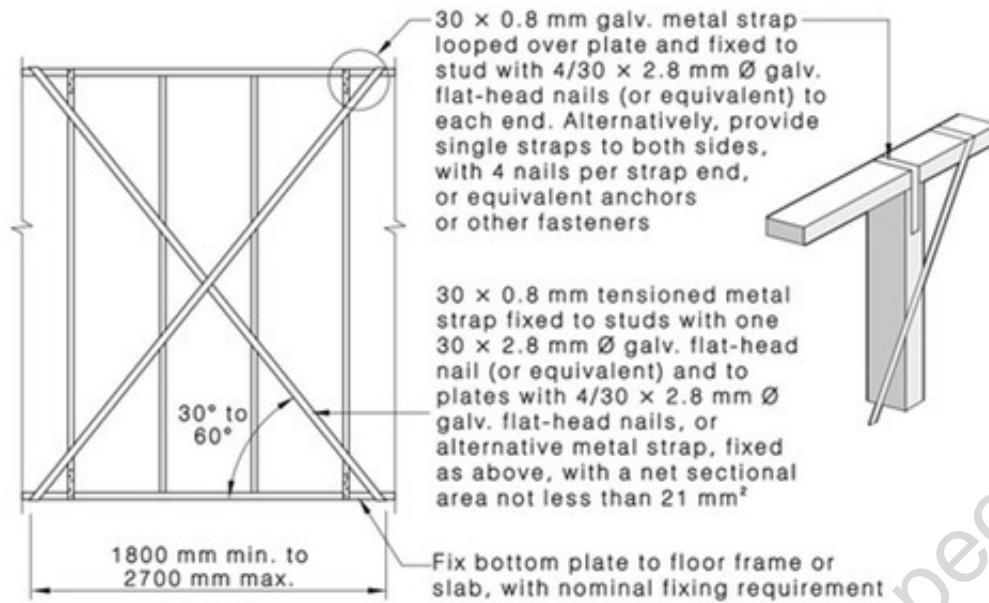
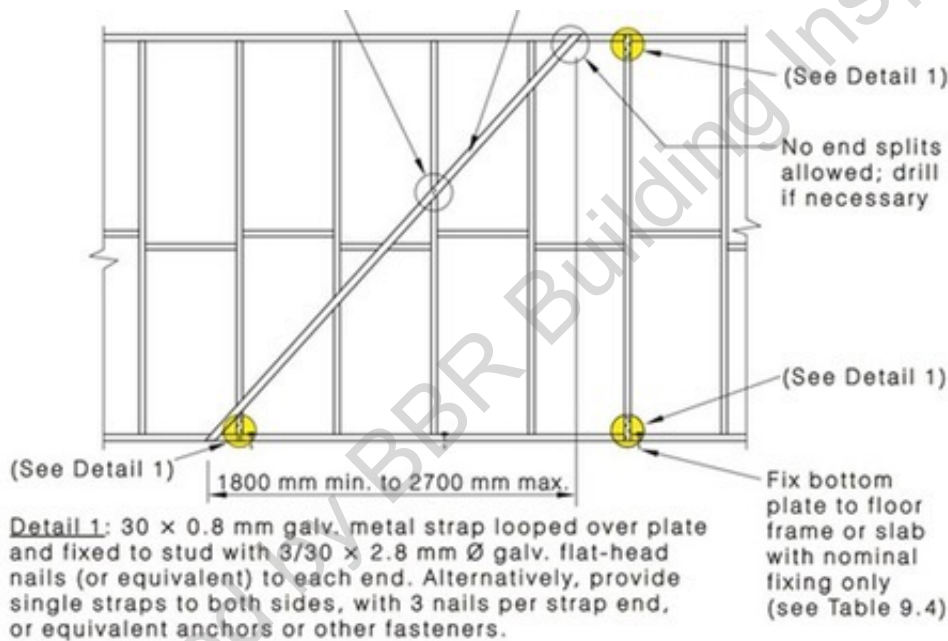
## (d) Metal straps—Tensioned—With stud straps

Finding: Missing metal straps to top and bottom plates

During my inspection I found no metal strap connections to the timber stud walls where the bracings installed.

"30 0.8 mm galv. metal strap looped over plate and fixed to stud with 3/30 2.8 mm galv. flat-head nails (or equivalent) to each end. Alternatively, provide single straps to both sides, with 3 nails per strap end, or equivalent anchors or other fasteners. x x Ø D e t a i l : 3 0 0 . 8"

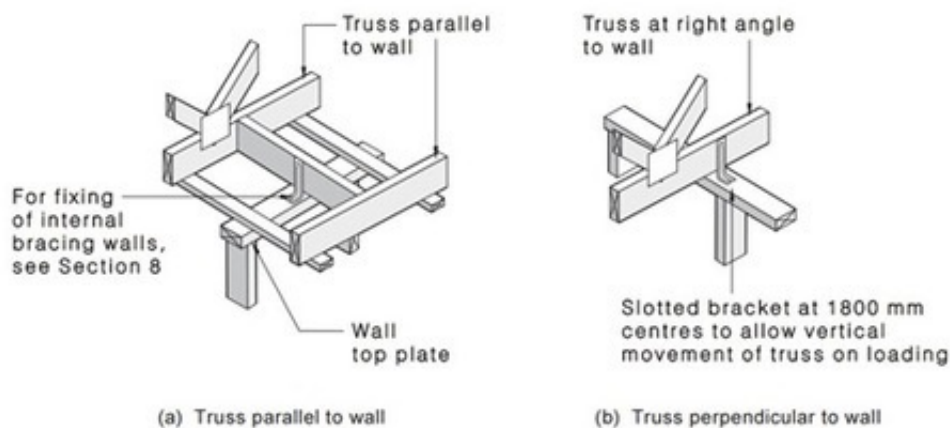
FIGURE 6.11 FIXING OF TRUSSES TO A NON-LOADBEARING INTERNAL WALL

No internal wall to truss brackets noted at the time of inspection, unless otherwise advised by the manufacturer. It is a requirement of Australian Standard, AS 1684 Residential Timber-Framed Construction, clause 6.2.5.2 Internal walls—Trussed roofs Non-loadbearing walls shall be kept a minimum of 10 mm below the underside of the bottom chord, or ceiling battens when used. Trusses shall be fixed to internal non-loadbearing walls as shown in Figure 6.11, or as required for bracing (see Clause 8.3.6.9).

Clause 8.3.6.9 Fixing of top of bracing walls;

3 For trussed roofs, where nominal fixings are permitted as above, the nominal fixings should permit vertical movement of the trusses. See Table 8.22, Items (a) and (i)

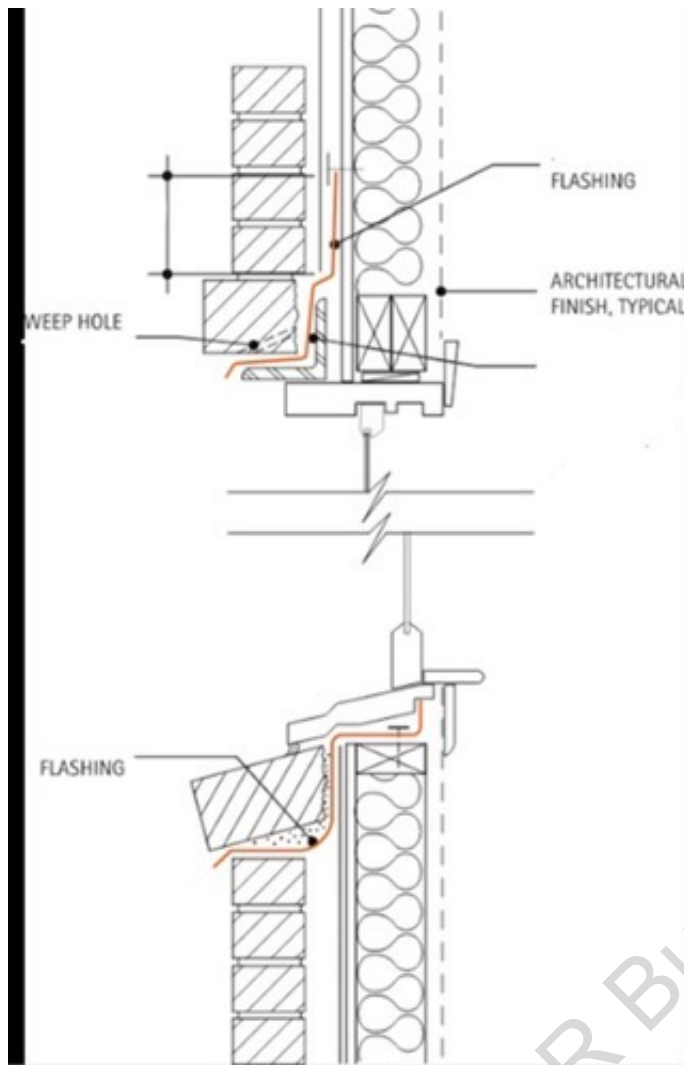
Finding: Missing windows sill and head flashings

Sill and head flashings were missing at the time of inspection.

B) 300 mm above the opening; and

turned up in the cavity not less than 150 mm above the opening; and embedded not less than 30 mm into the masonry veneer; and attached to the window or wall framing.
